Oasis

TROUBLESHOOTING GUIDE

W0E36C2DB1 / H0E36C2MR1

MINI SPLIT SYSTEM

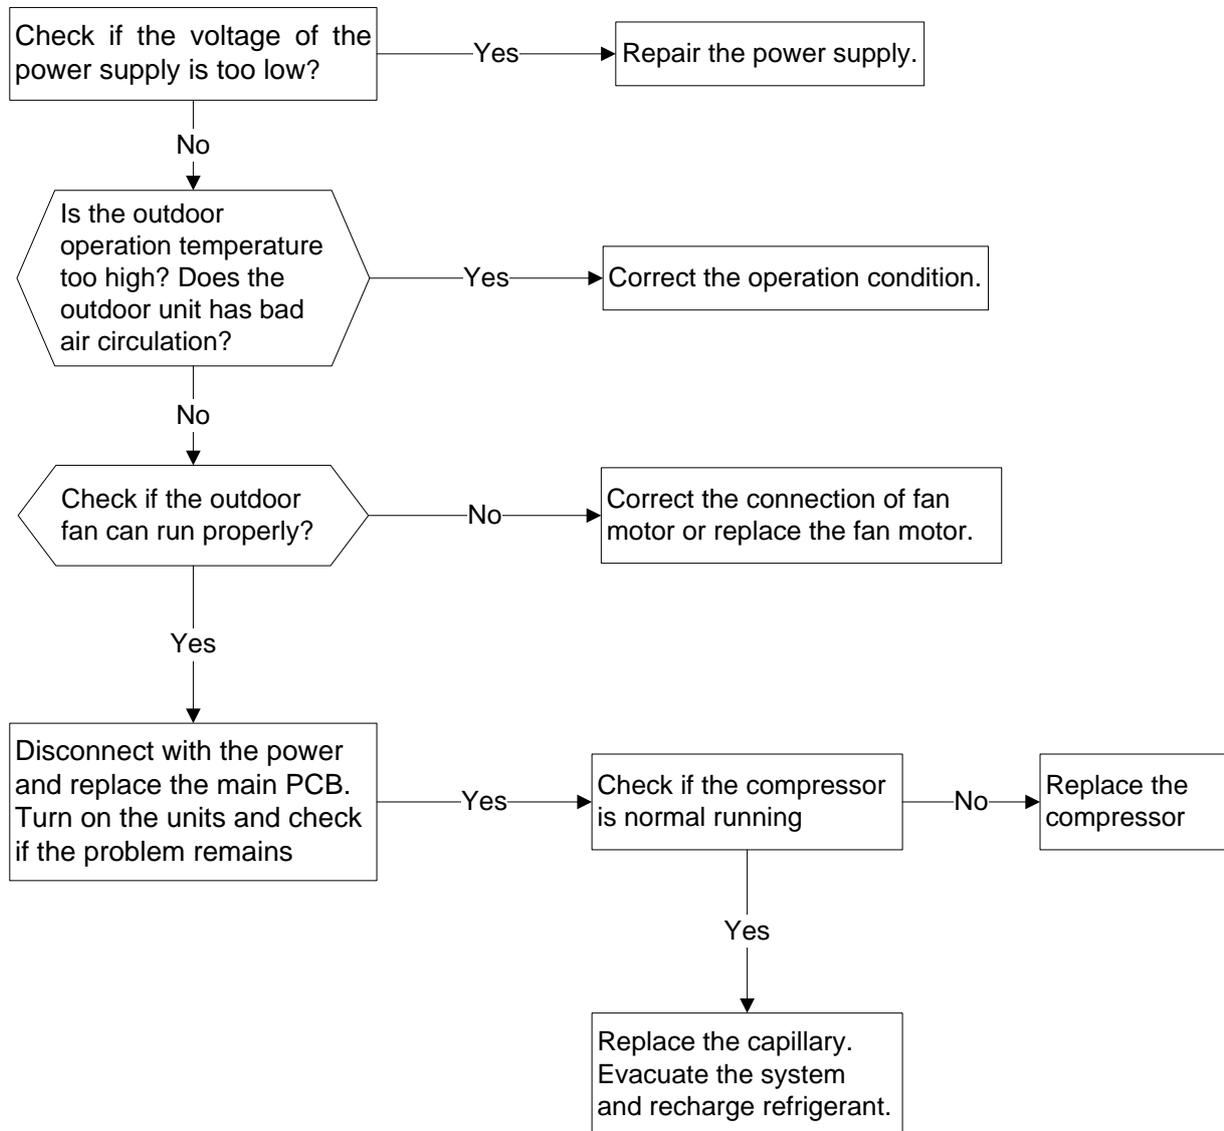
9.2.1 Over current protection occurs 4 times diagnosis and solution

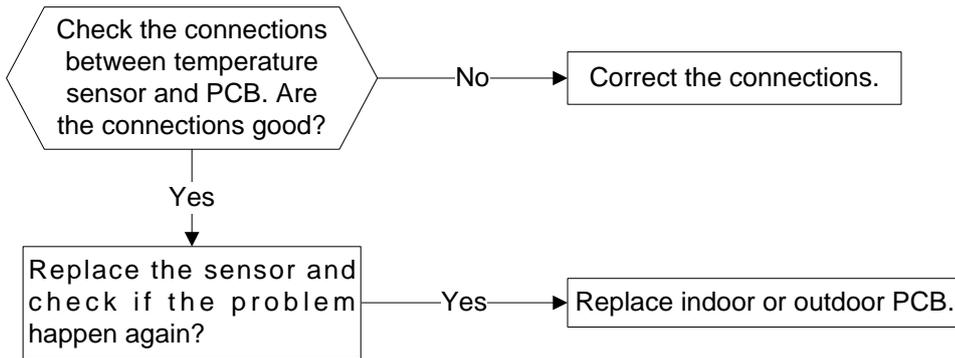
9.2.2 The temp sensor is open circuit or short circuit diagnosis and solution

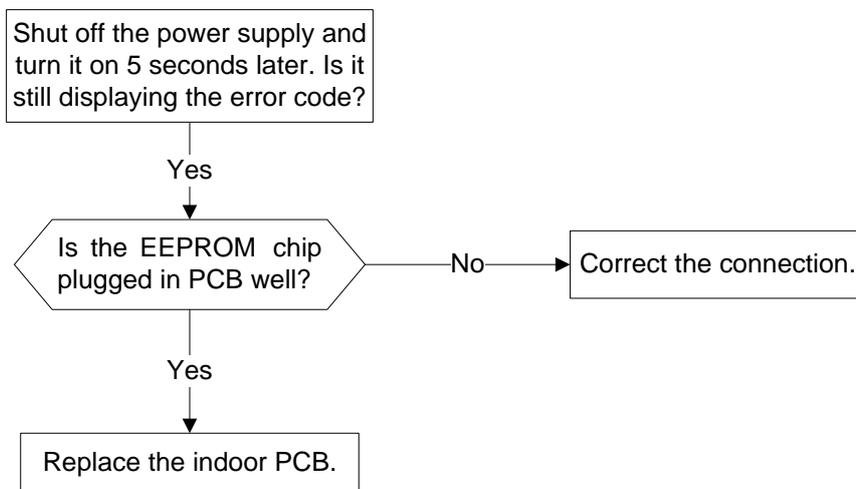
9.2.3 EEPROM parameter error diagnosis and solution

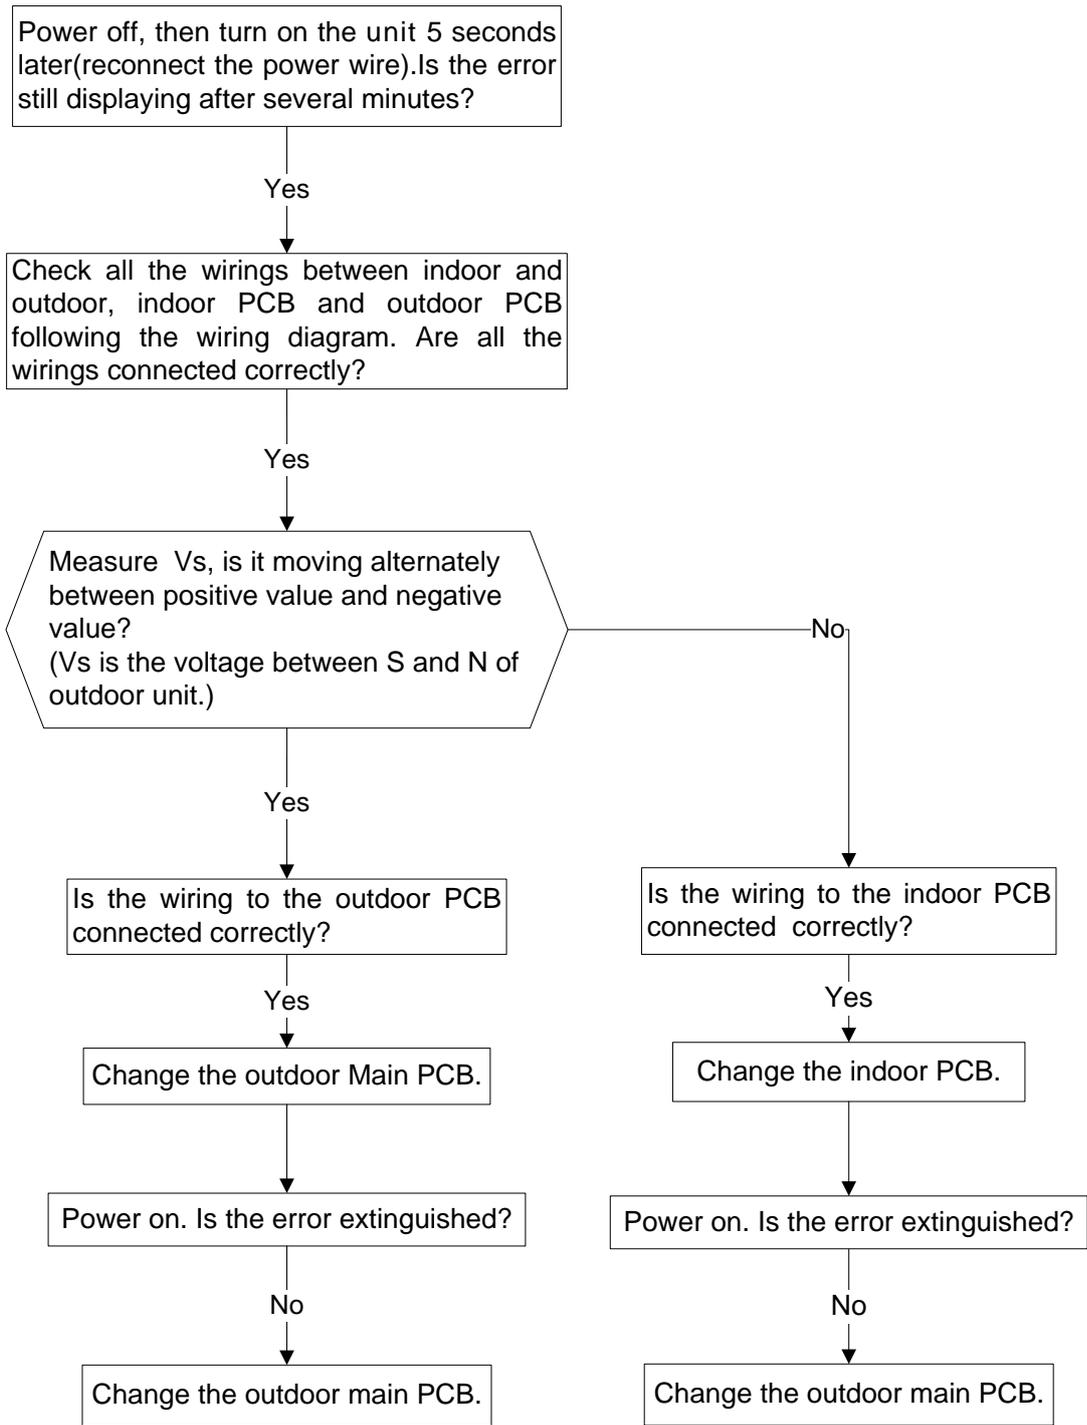
9.2.4 Communication malfunction between indoor unit and outdoor unit diagnosis and solution
